CORVALLIS WALNUT BOULEVARD ROAD SAFETY AUDIT REPORT

FEBRUARY 2026

PREPARED BY DKS ASSOCIATES

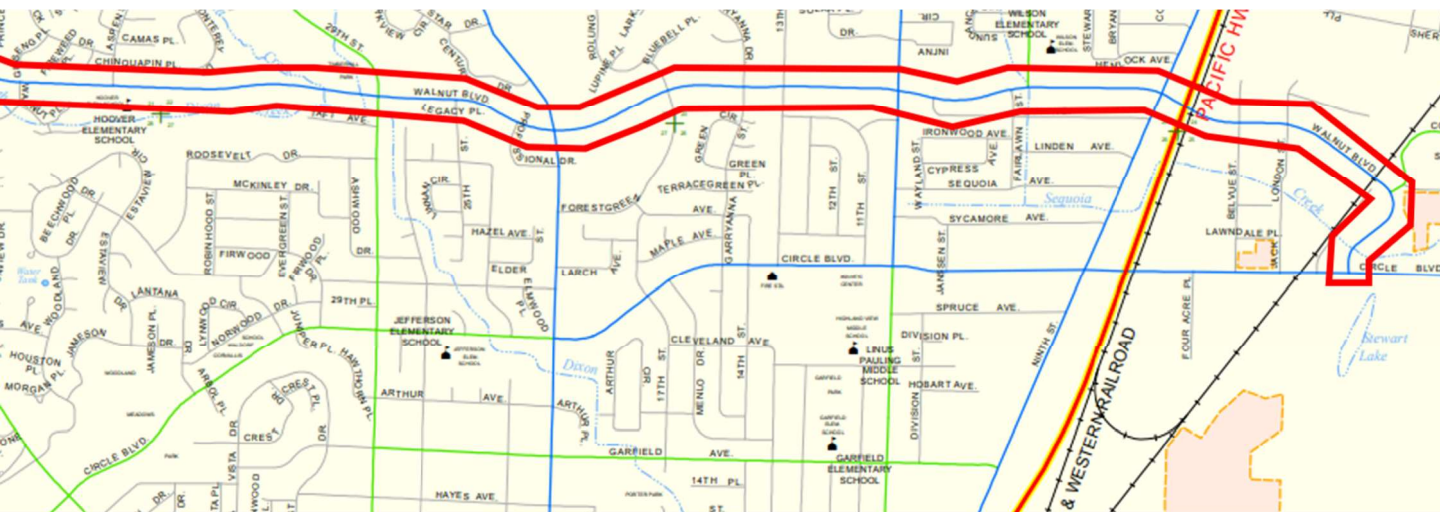
FIGURE 2. WALNUT BOULEVARD RSA STUDY CORRIDOR

ing Walnut Boulevard, between NW Fair Oaks Drive and Circle Boulevard, as shown in Figure 2.¹

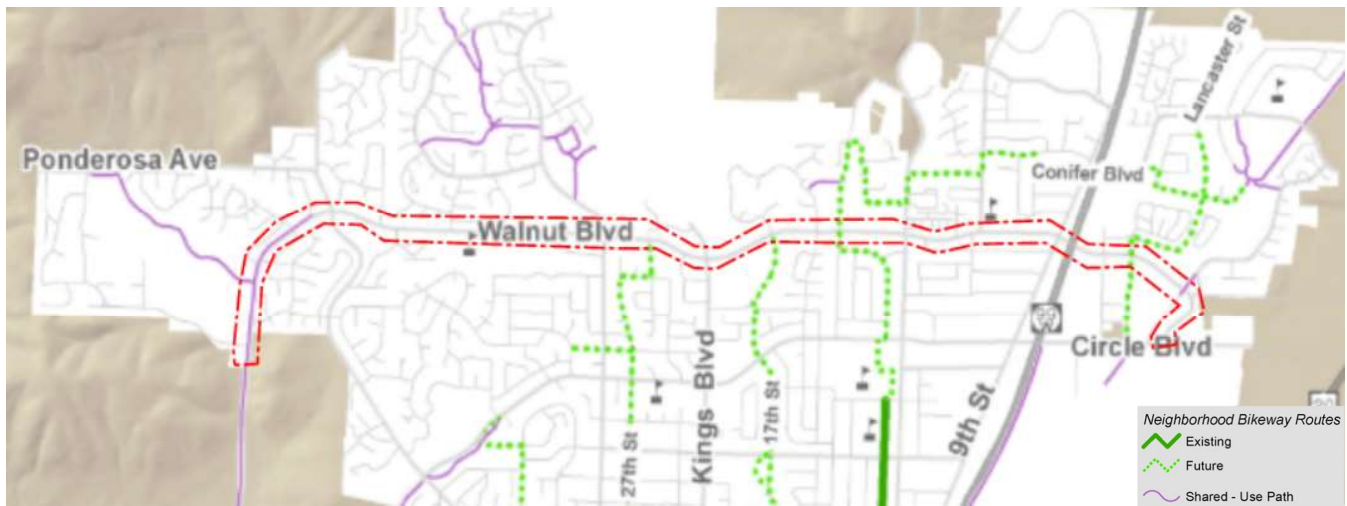
FIGURE 7: CORVALLIS NEIGHBORHOOD BIKEWAY ROUTES

- **Public Parks:** There are two parks located near the study area. Timberhill Park is situated north of the NW 29th Street and Walnut Boulevard intersection, while Dr. Martin Luther King Jr. Park is located west of Walnut Boulevard between NW Fair Oaks Drive and NW Maser Drive.
- **Bike Routes:** As shown in Figure 7, an existing shared-use path is present within the study area between NW Fair Oaks Drive and NW Audene Drive. The figure also identifies two planned neighborhood bikeway routes at NW 25th Street and NW Rolling Green Drive that are proposed to connect to Walnut Boulevard. In addition, two future neighborhood bikeway routes are planned to cross Walnut Boulevard at NW 13th Street and NE Jack London Street.

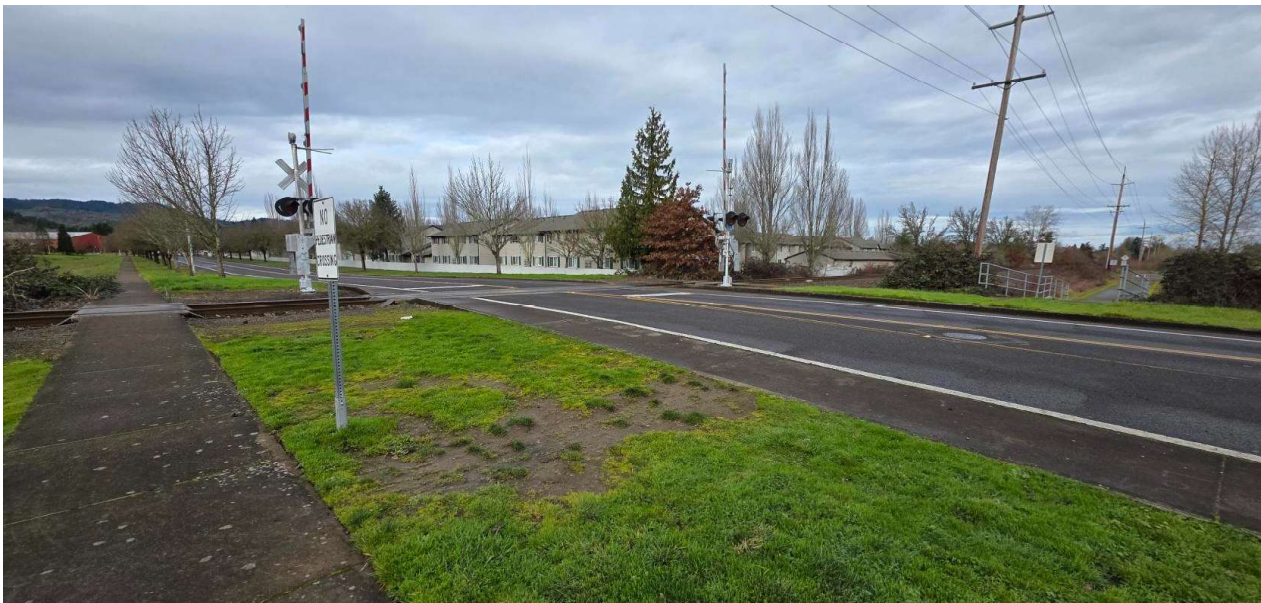
FIGURE 12. EXISTING RAILROAD CROSSING WITH SHARED USE PATH AND NO CROSSING SIGNAGE

This segment of the corridor is characterized by industrial land uses from Circle Boulevard to NE Jack London Street, where it transitions to a medium-density residential area. Most crashes in this area were angular in nature, with contributing factors that included carelessness, failure to yield the right of way, and stop sign violations. A previous safety evaluation was completed by Kittleson Associates, Inc. between the NE Jack London Street and Circle Boulevard intersections prior to this RSA and is included in the appendix. Recommended countermeasures from that effort are incorporated into the Safety Solutions section below.¹² As noted in that previous RSA, a short shared-use path in this area connects to a sidewalk along Walnut Boulevard. Crossing at this location is prohibited by signage, although worn pavement and ground areas indicate that path users frequently cross at this location. This can be seen in Figure 12 below.

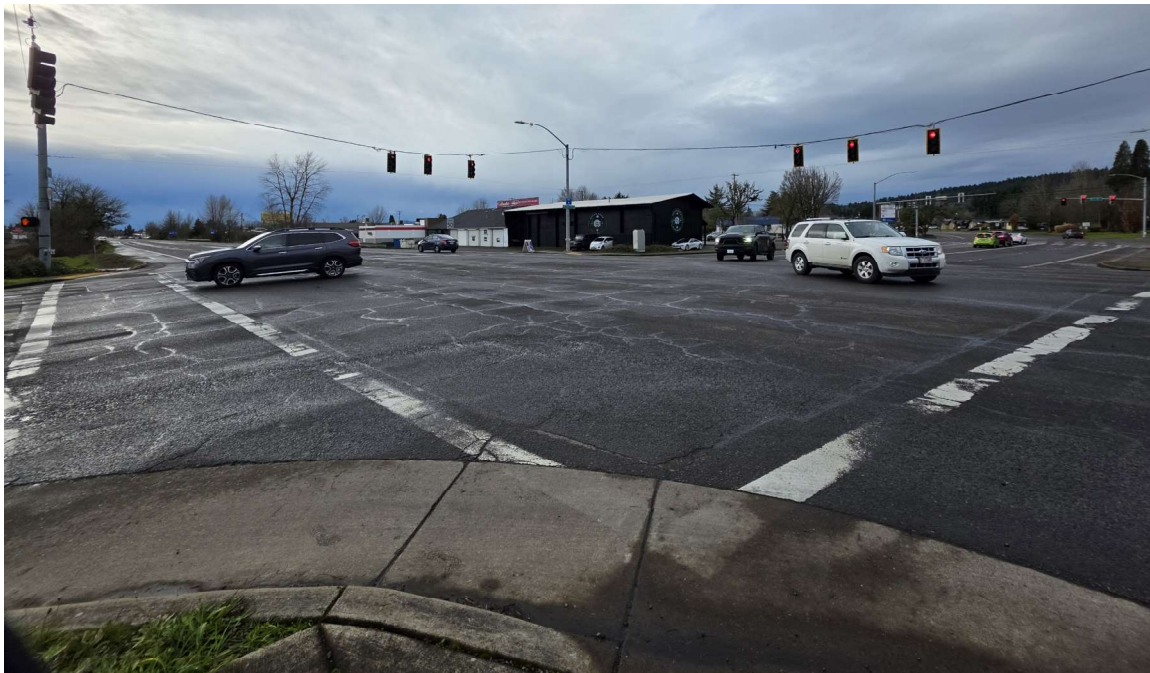
FIGURE 13. WALNUT BOULEVARD & OR99W INTERSECTION

This roadway segment includes two key intersections along the Walnut Boulevard corridor, at OR 99W and NW 9th Street. These intersections experienced two of the highest crash frequencies on the corridor, with most crashes involving signal violations. The OR99W intersection can be seen in Figure 13 below. The RSA identified a need for additional measures at the NW 9th Street intersection to better protect bicyclists, as southbound right-turning vehicles were observed having close calls with southbound bicyclists. It was also noted that the curb ramps at the OR 99W intersection do not have a flat turning space and some pushbuttons appear difficult to reach from a wheelchair. At the time of the RSA, the OR99W and NW 9th Street intersections were seen to not be coordinated as vehicles were observed queuing between the two intersections and periodically blocking the intersection. The coordination of these traffic signals has been updated as of February 2026.

- If a lane reallocation occurs along Walnut Boulevard at this location, add a two-way left-turn lane so that business driveways approximately 200 feet west of the Walnut Boulevard and NW 9th Street intersection can use it to access their driveways
- Reconstruct existing curb ramps to meet current ADA standards at the OR99W and Walnut Boulevard intersection
- Extend the OR 99W shared-use path from Circle Boulevard to Conifer Boulevard, with a wide pedestrian and bicyclist crosswalk for the east leg of the Walnut Boulevard intersection
- If full signal replacement is to occur, consider a protected intersection at the Walnut Boulevard and NW 9th Street intersection

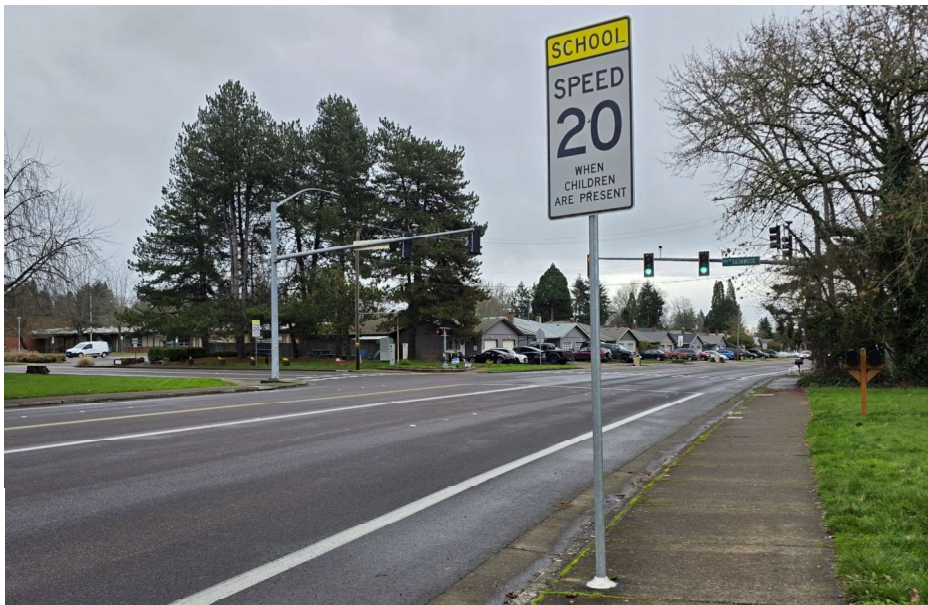
FIGURE 14. WALNUT BOULEVARD AND NW SATINWOOD STREET INTERSECTION

This focus area includes the NW Highland Drive and NW Satinwood Street signalized intersections. The NW Highland Drive intersection experienced the highest number of crashes within the focus area. Crash patterns in this focus area consisted primarily of rear-end crashes at the NW Satinwood Street intersection and turning-related crashes at the NW Highland Drive and NW Fairlawn Street intersections. The Letitia Carson Elementary School is also located near this focus area, and school speed zone signage is present and active when children are present, as shown in Figure 14. During the RSA field visit, it was observed that vehicles in the area did not appear to be following the school zone speed limit. However, no data was collected to verify vehicle speeds. Vehicle queuing was also observed at the eastbound left-turn lane at the NW Satinwood Street intersection. At the NW Highland Drive intersection, red-light running was observed for eastbound left-turn movements from Walnut Boulevard onto NW Highland Drive, as well as a near miss involving a southbound right-turning vehicle and a student crossing the intersection. As noted, the recent closure announcement of the Letitia Carson Elementary School may make some of these suggestions unneeded.

- Evaluate adding a crosswalk to the west leg of the Walnut Boulevard and NW Satinwood Street intersection, including ADA curbs ramps for the relevant approaches
- Widen the south sidewalk between NW Fairlawn Street and NW Satinwood Street for both pedestrian and bike travel
- If full signal replacement is to occur, consider a roundabout or protected intersection at the Walnut Boulevard and NW Highland Drive intersection
- Evaluate limiting the vehicle movements at Fairlawn Street on Walnut Boulevard to be right-in, right-out only to extend the eastbound left-turn lane at the Walnut Boulevard and NW Satinwood Street intersection, adding approximately 75 feet of additional storage

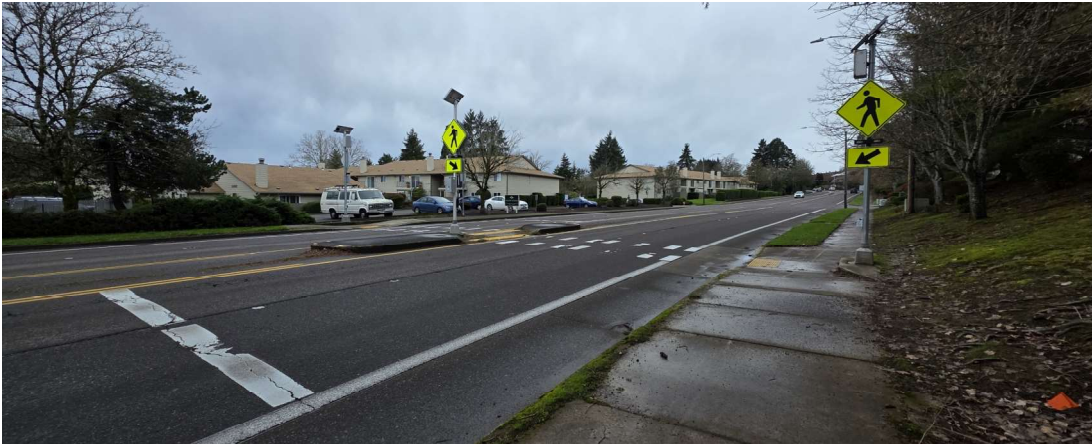
FIGURE 15. MIDBLOCK CROSSING BETWEEN NW 13TH STREET AND NW GARRYANNA DRIVE

Focus Area 4 features an RRFB midblock crossing located between NW 13th Street and NW Garryanna Street as seen in Figure 15. The area also contains signalized intersections at NW Kings Boulevard and NW Rolling Green Drive, which had the highest number of crashes within the focus area, mostly involving turning vehicles. Adjacent land uses are primarily accessed via side streets along Walnut Boulevard, with dedicated left turn lanes to accommodate turning movements without impeding through traffic. RSA field observations noted a high volume of pedestrians, bicyclists, and scooter riders using the NW Kings Boulevard intersection.

- Replace the undersized MUTCD R1-5b "STOP HERE FOR PEDESTRIANS" sign with a standard-size sign and trim surrounding vegetation to ensure full visibility at the RRFB enhanced midblock crossing between NW Garryanna Street and NW 13th Street intersections

- Replace the existing sign (MUTCD R3-7R) at the beginning of the dedicated right-turn lane for the NW Kings Boulevard and Walnut Boulevard intersection with the MUTCD R4-4 "Begin Right Turn Lane Yield to Bikes" sign

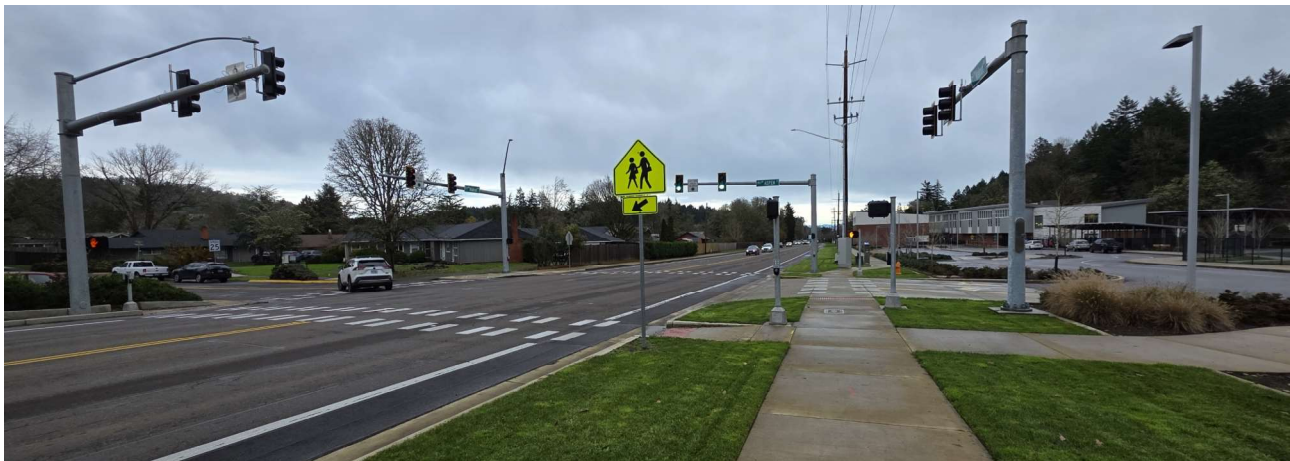
FIGURE 16. NW ASPEN STREET INTERSECTION WITH BESSIE COLEMAN SCHOOL ENTRANCE

This focus area contains signalized intersections at NW 29th Street and NW Aspen Street. The south approach of the Aspen Street intersection serves as an access point for Bessie Coleman Elementary School, as shown in Figure 16. This segment of the corridor lacks a two-way left turn lane, so left-turning vehicles outside the signalized intersections further disrupt traffic flow and increase conflict points. RSA field observations noted congestion for eastbound left-turning vehicles at the NW Aspen Street intersection, causing vehicles to maneuver around in the adjacent through lane.

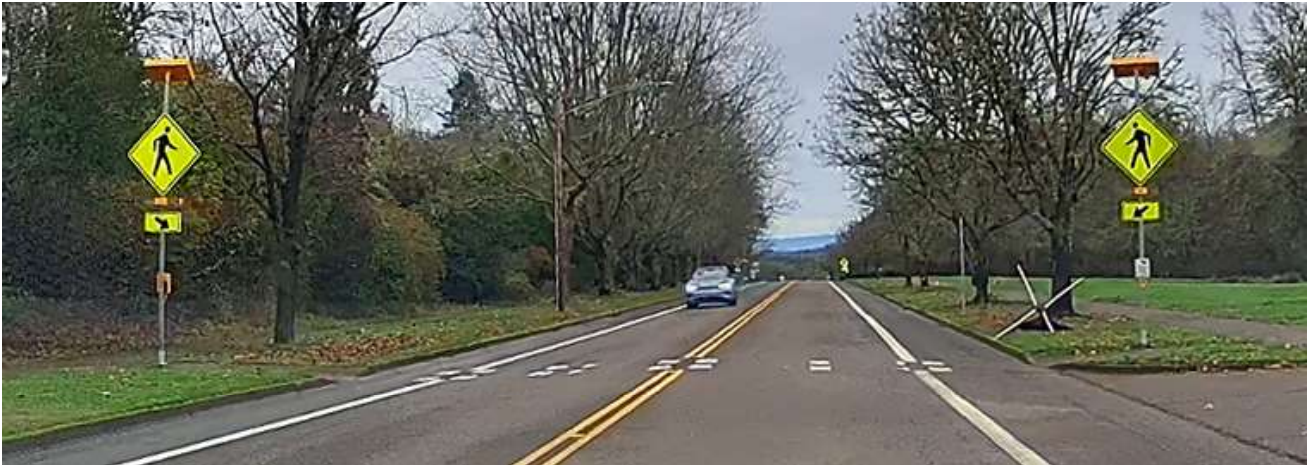
FIGURE 17. RRFB ENHANCED CROSSING AT MLK JR. PARK

This segment of the corridor includes MLK Jr. Park and contains a single signalized intersection at NW Glenridge Drive and NW Witham Hill Drive, along with a RRFB enhanced crossing between NW Elmwood Drive and NW Maser Drive, as seen in Figure 17. A previous safety evaluation at this intersection was completed by DKS Associates prior to this RSA and is included in the appendix. Recommended countermeasures from that effort are incorporated into the Safety Solutions section below. Crashes in this area primarily involve turning movements at the signalized intersection or fixed object collisions, with contributing factors including inattentiveness, fatigue, and carelessness.

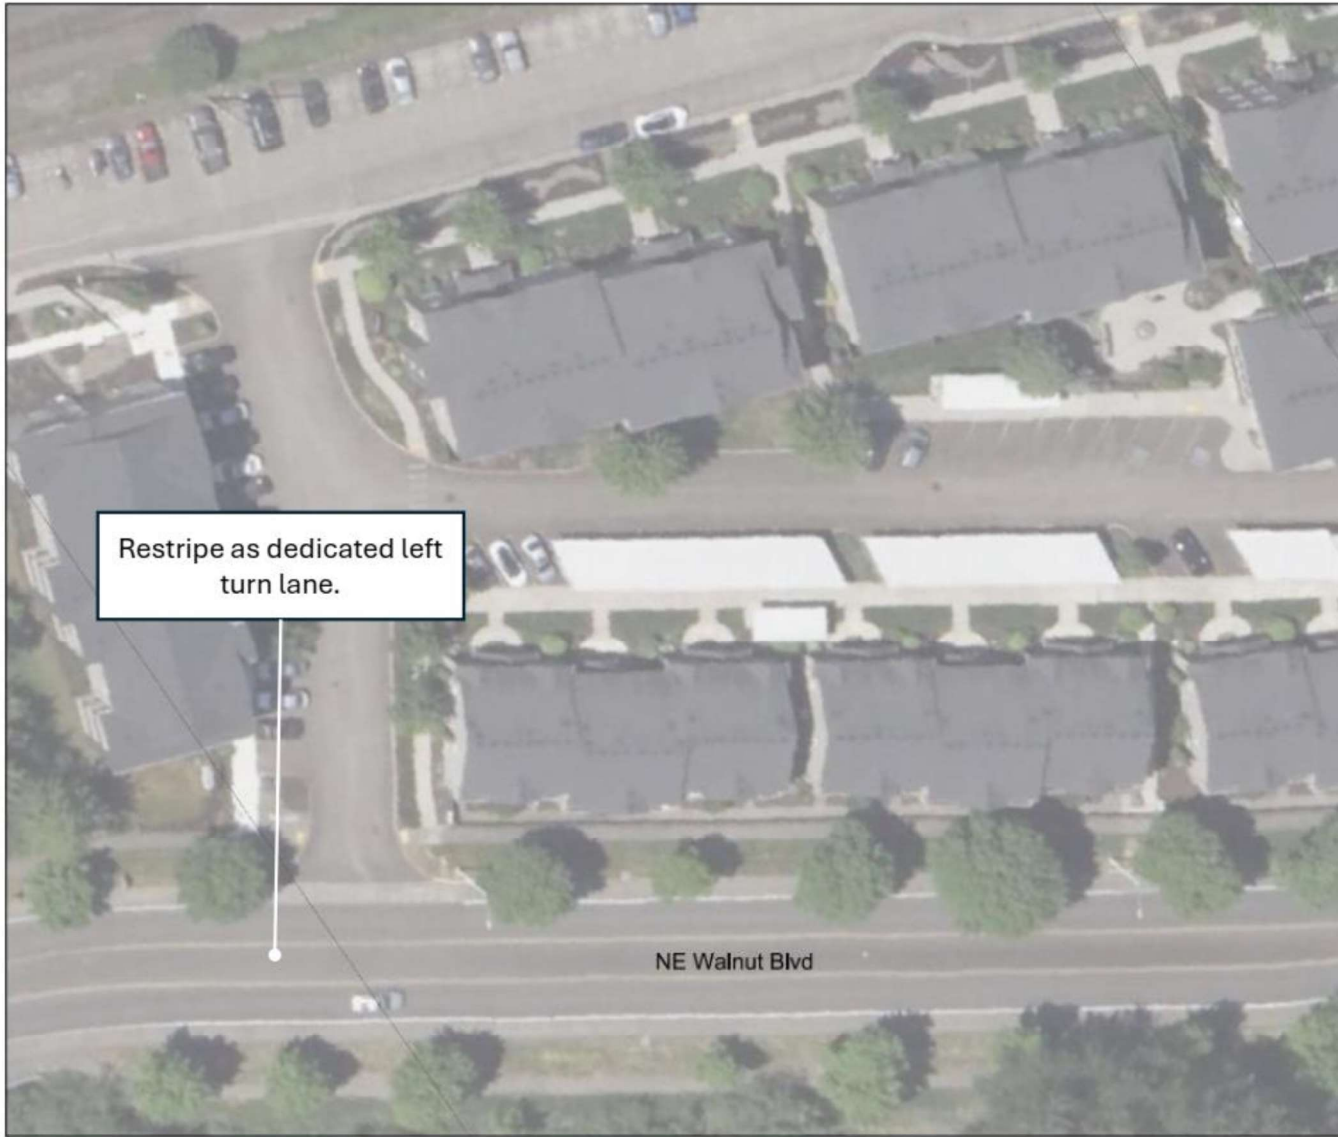
When new signage is installed, use larger post for potential RRFB installation as needed based on motorist yielding compliance.

Figure 54: Walnut Boulevard Spot Specific Recommendations – Page 3

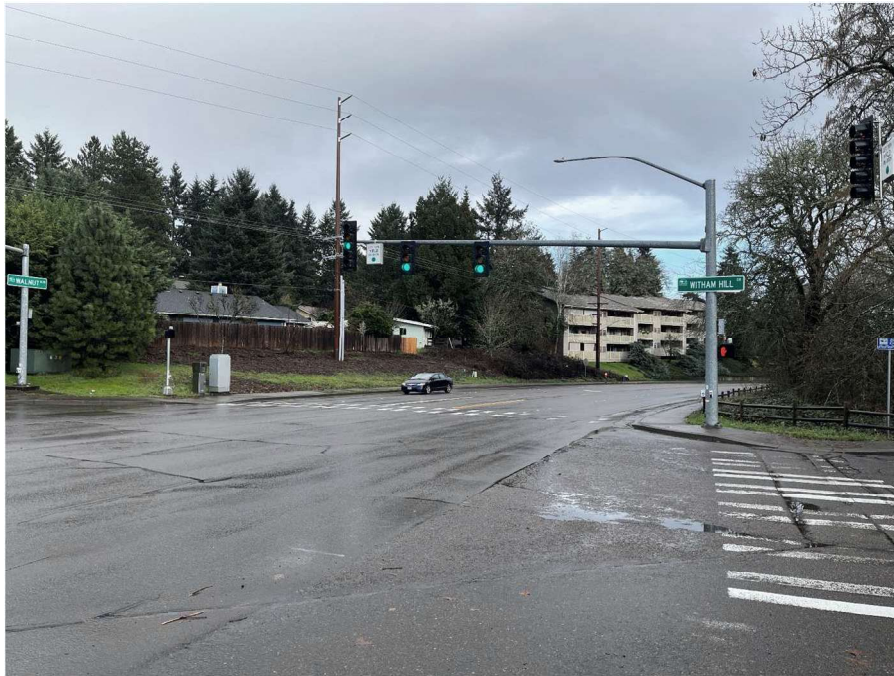
FIGURE 2: SOUTHWEST CORNER, LOOKING EAST ALONG WALNUT BOULEVARD

The study intersection is located in the far northwest quadrant of the City of Corvallis and it serves both local and regional traffic. Walnut Boulevard (and 53rd Street, as an extension) serves as a circumferential route in Corvallis on the west and north sides. Therefore, there is a large portion of east-west commuter pass-through traffic at the intersection. However, the intersection is surrounded by primarily low-density residential housing, and it serves as a gateway to many neighborhoods. The 35 mile per hour (MPH) section of Walnut Boulevard generally extends from Fair Oaks Drive in the southwest to Highland Drive in the east.

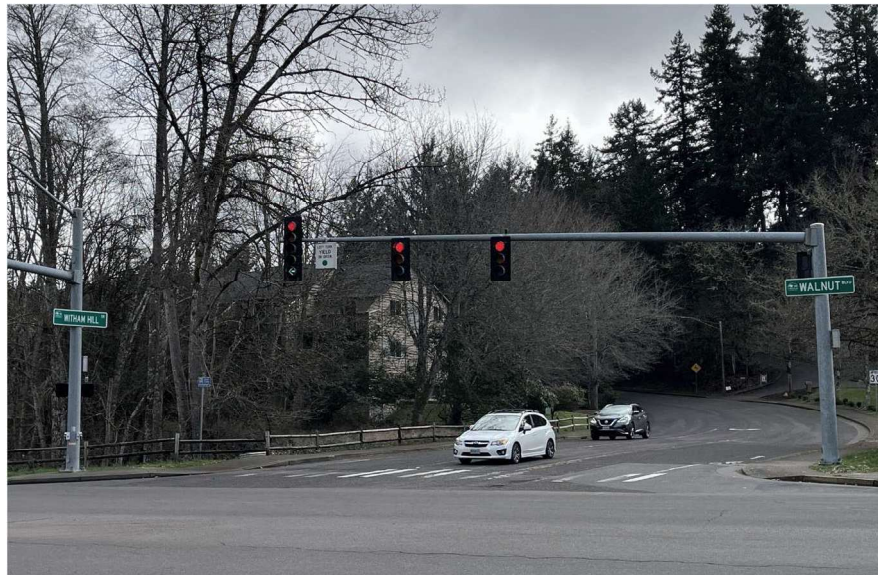
FIGURE 3: LEFT-TURN SIGNAL HEAD WITH RED BALL AND GREEN ARROW

Each of the four intersection approaches has two standard 3-section signal heads for the through-right lanes and one five-section signal head for the left-turn lane to provide permitted-protected phasing. The left-turn heads also have accompanying 'Yield' signs to clarify what the green ball indicates. The five-section signal heads can be unclear to drivers, as they can show a red ball and green arrow indication at the same time during certain signal phasing, and they are no longer an ODOT standard signal head type. The northbound and southbound approaches also have near-side supplemental signal heads located on the southwest and northeast signal poles. Those two signal heads, however, have older 8-inch lenses for the yellow and green indications. No reflectorized backplates are present on any of the signal heads.

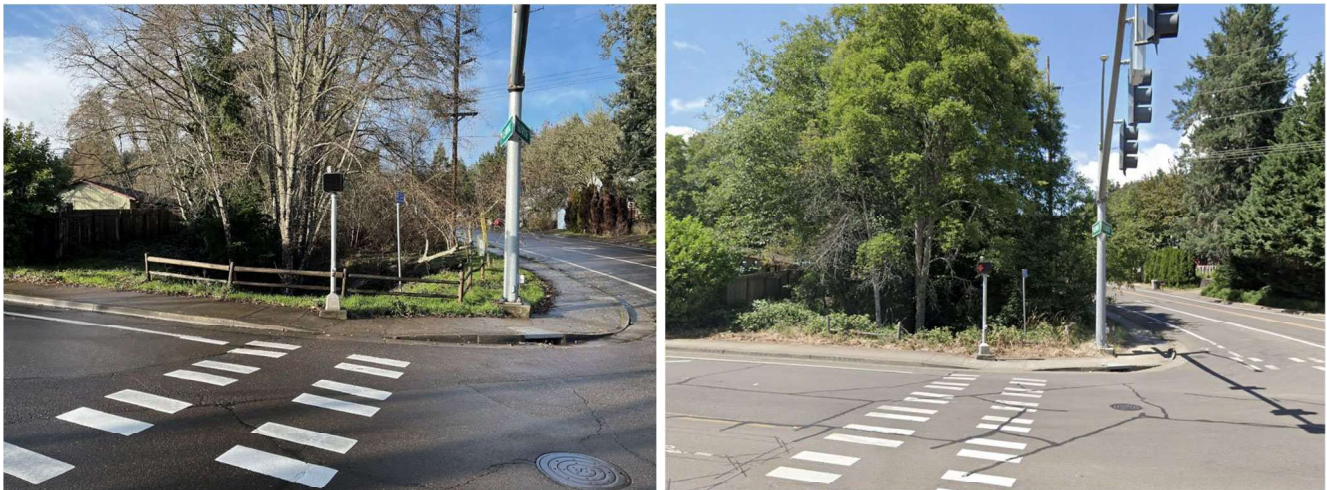
FIGURE 4: VEGETATION IN NW CORNER (JANUARY 2024 & JULY 2019¹⁰)

The study intersection and surrounding area has significant vegetation along all approaches and at each corner, which can restrict sight distance. While preliminary sight distance measurements did not identify a vegetation obstruction in January, it is possible that sight distance may be impacted at other times of year. This is especially true for the northwest corner (see Figure 4), which has a lot of brush and mature trees in the riparian zone/creek.
